紅外線外牆探測報告 Infrared Survey Test Report on External Façade

香港大坑宏豐臺1號
偉景大廈6期
Stage 6 Grandview Mansions
1 Wang Fung Terrace, Tai Hang, Hong Kong

Survey Element 探測位置	External wall 外牆 (Before Renovation 維修前)
Our Job No. 工程項目編號	E895-5713
Our Order No. 工程指令編號	21022601
Date of Survey 探測日期	2021-03-25
Report No. 報告編號	IR2103617_Stage 6
Date of Report 報告日期	2021-03-25
Tested By 檢測人員	Michael C. H. Leung (Level I Thermographer)

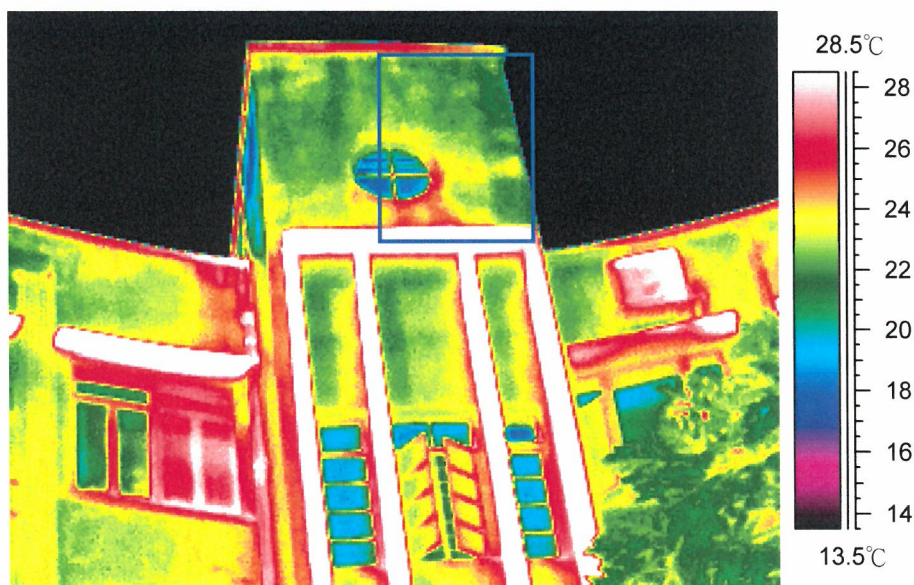
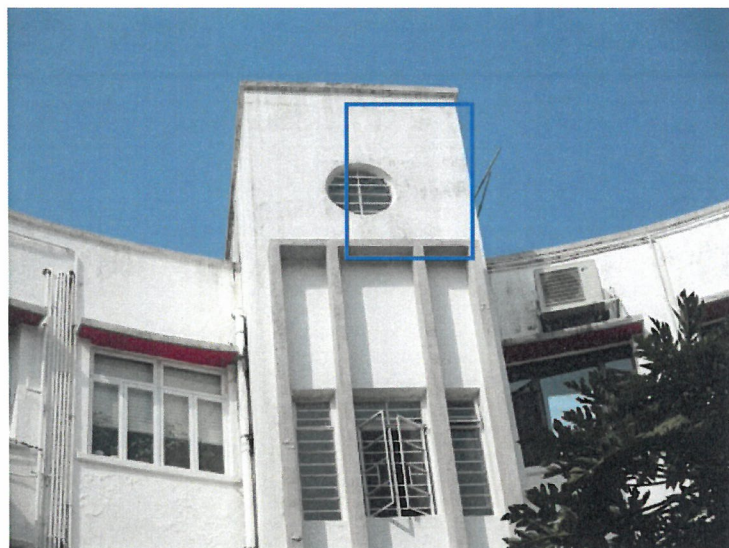
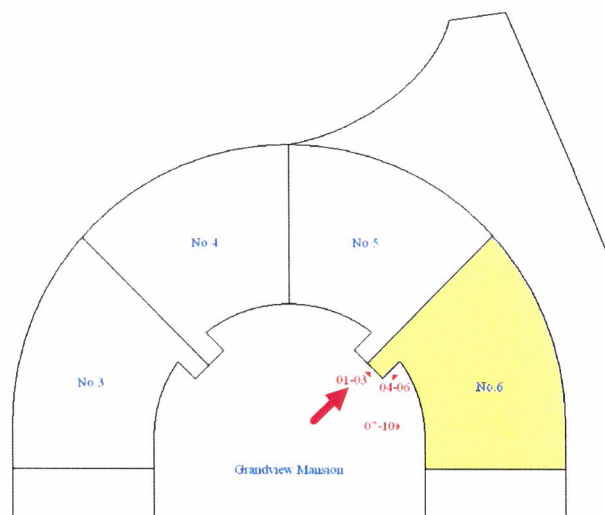
Image 圖譜: 01
 Location 位置: Stage 6 Grandview Mansion 偉景大廈6期
 Floor 樓層: 3-R/F

Areas with unusual temperature inside boxes in the infrared spectrum are locations of possible defects

Classification 分類	Quantity 數量	Estimate Area 估計面積 (m ²)
I (General 一般)	1	3
II (Serious 嚴重)	-	-
III (Other Possible 其他可能)	-	-

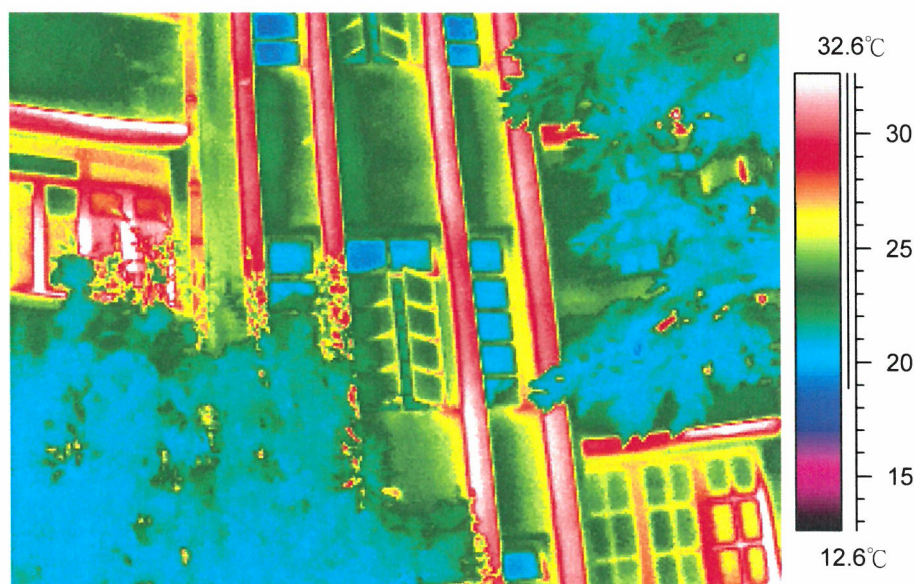
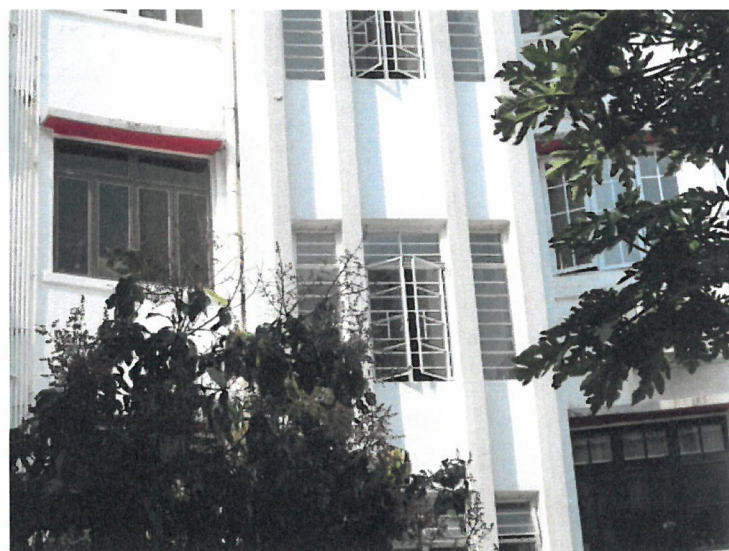
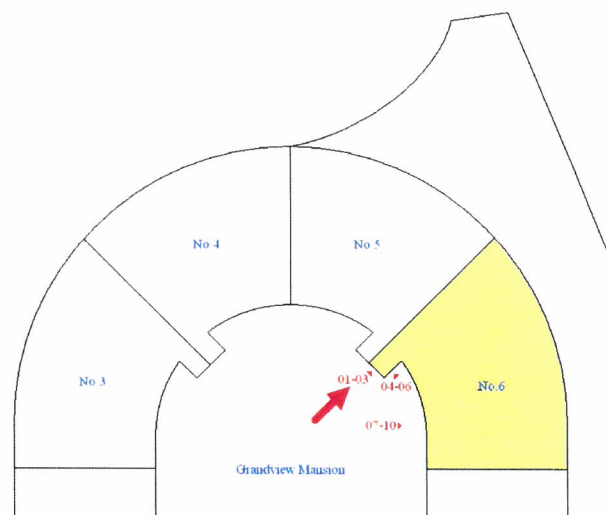
Image 圖譜: 02
 Location 位置: Stage 6 Grandview Mansion 偉景大廈6期
 Floor 樓層: 1-2/F

Areas with unusual temperature inside boxes in the infrared spectrum are locations of possible defects

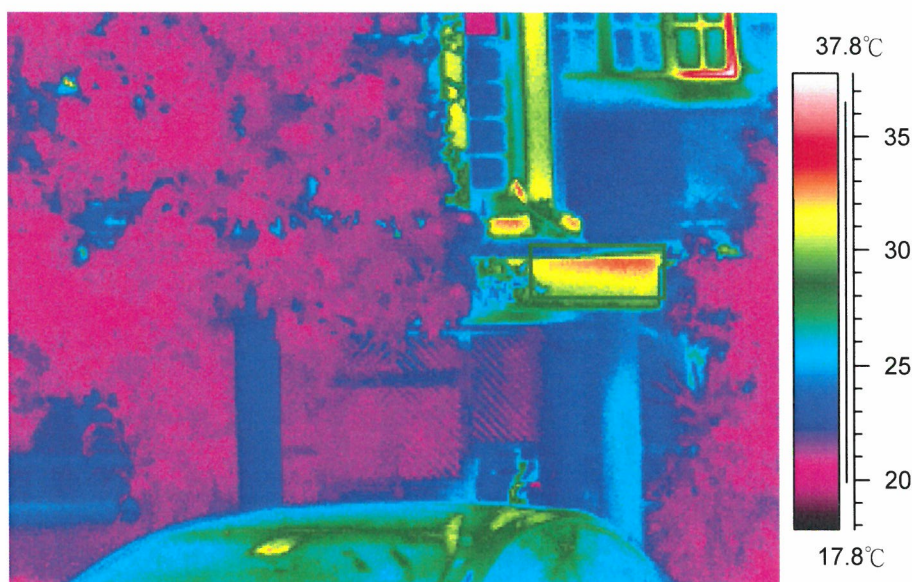
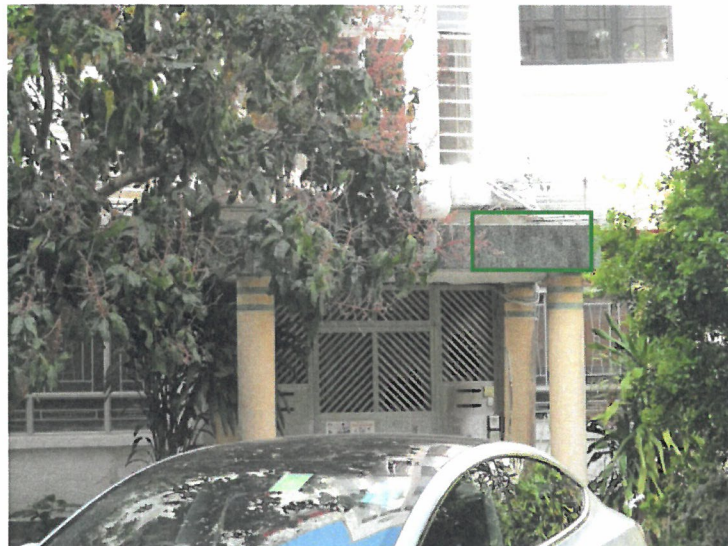
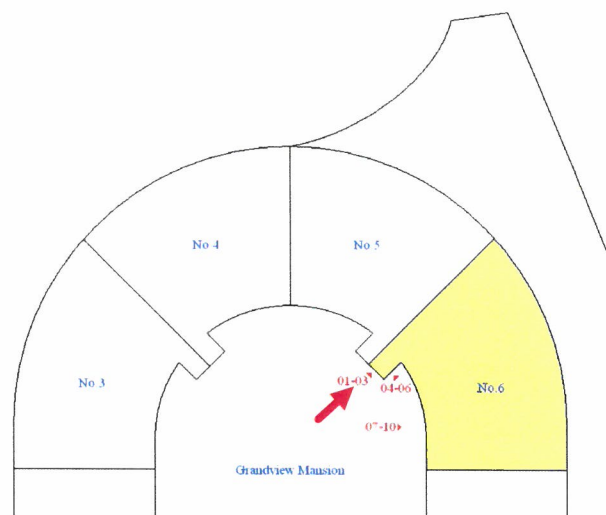
Image 圖譜: 03
 Location 位置: Stage 6 Grandview Mansion 偉景大廈6期
 Floor 樓層: G-1/F

Areas with unusual temperature inside boxes in the infrared spectrum are locations of possible defects

Classification 分類	Quantity 數量	Estimate Area 估計面積 (m ²)
I (General 一般)	-	-
II (Serious 嚴重)	-	-
III (Other Possible 其他可能)	1	1

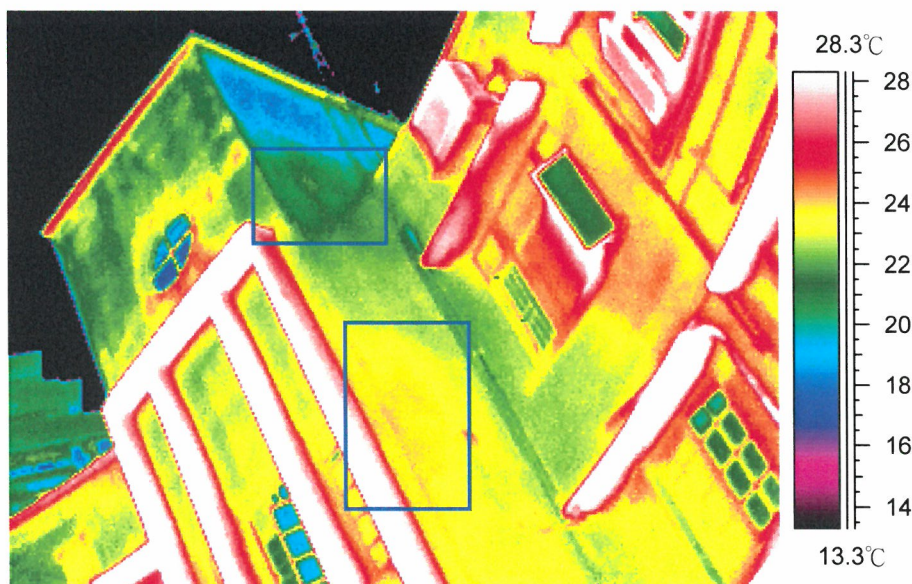
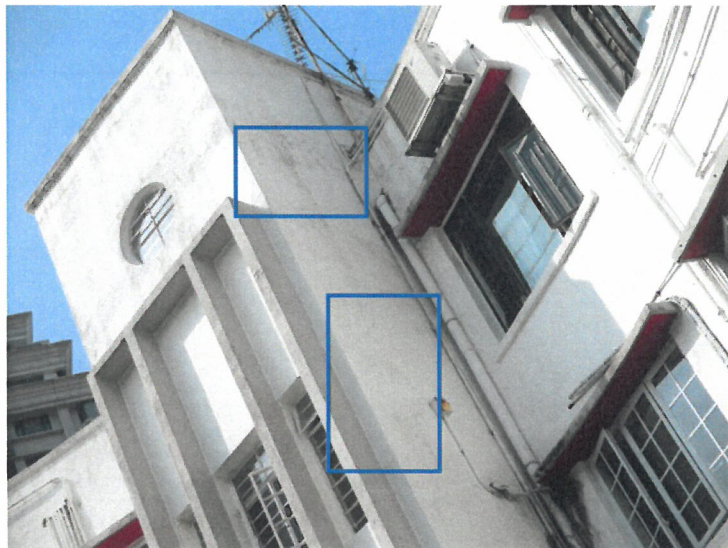
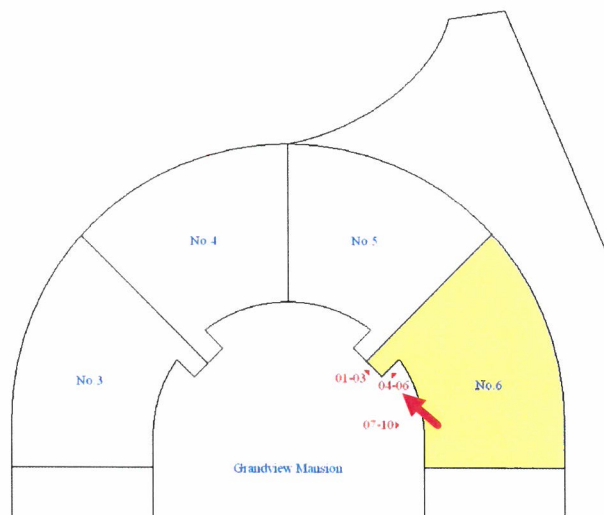
Image 圖譜: 04
Location 位置: Stage 6 Grandview Mansion 偉景大廈6期
Floor 樓層: 3-R/F

Areas with unusual temperature inside boxes in the infrared spectrum are locations of possible defects
紅外線圖譜中，方格內溫度相對異常的部份是可能缺損的位置。

Classification 分類	Quantity 數量	Estimate Area 估計面積 (m ²)
I (General 一般)	2	3
II (Serious 嚴重)	-	-
III (Other Possible 其他可能)	-	-

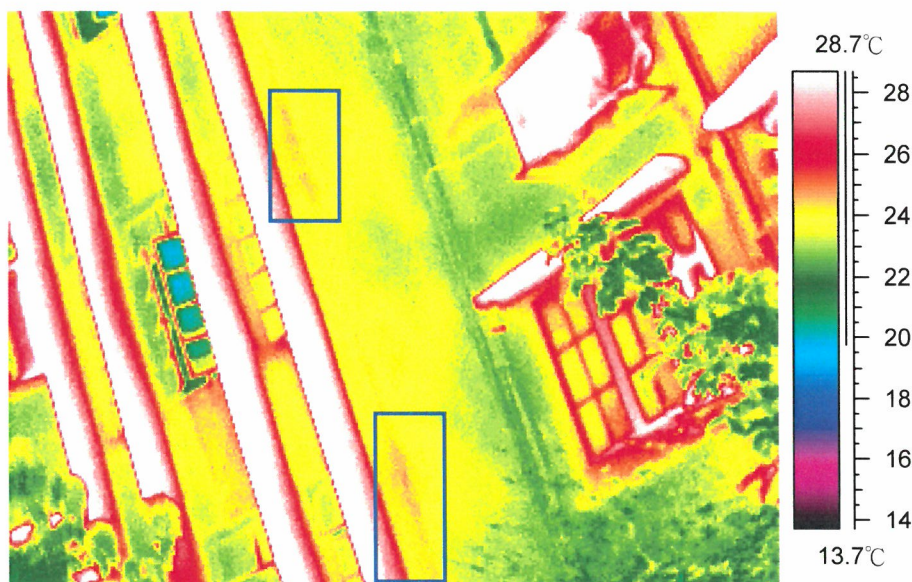
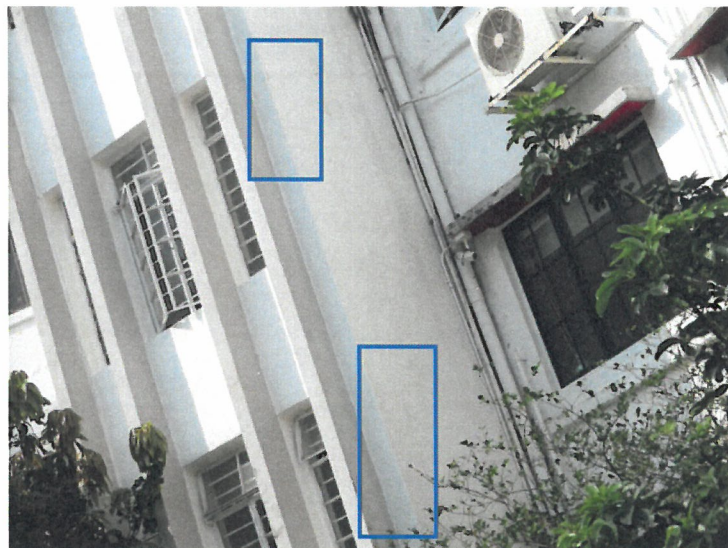
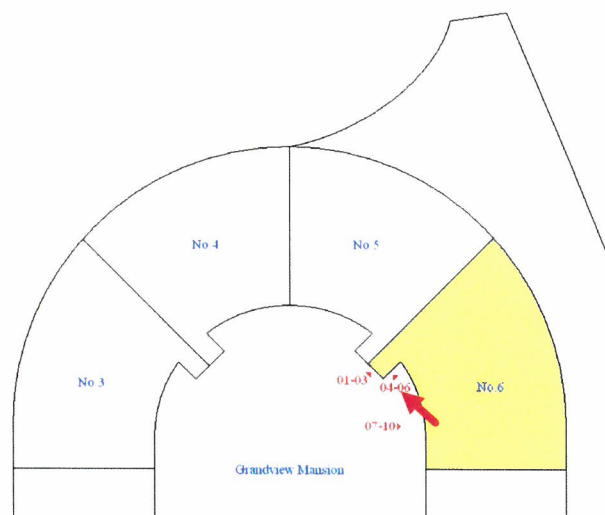
Image 圖譜: 05
Location 位置: Stage 6 Grandview Mansion 偉景大廈6期
Floor 樓層: 1-2/F

Areas with unusual temperature inside boxes in the infrared spectrum are locations of possible defects

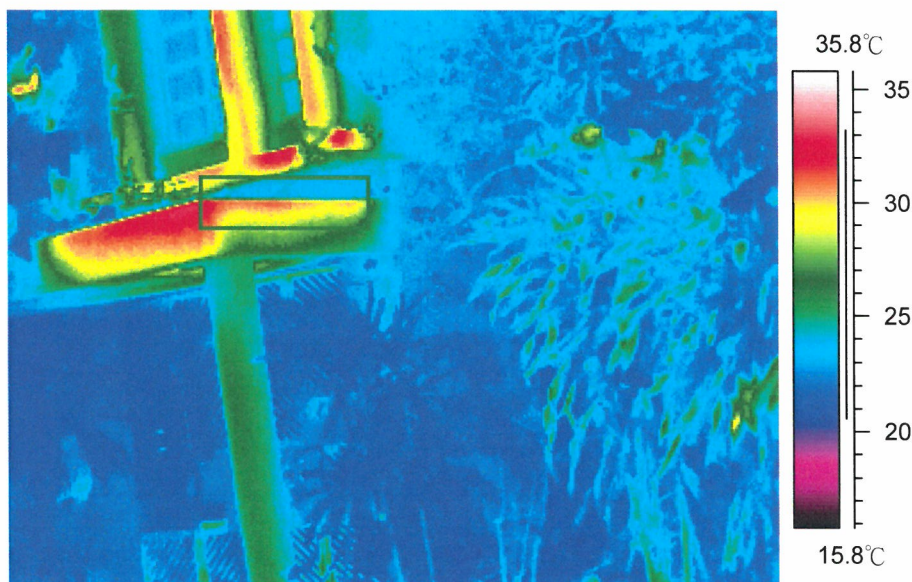
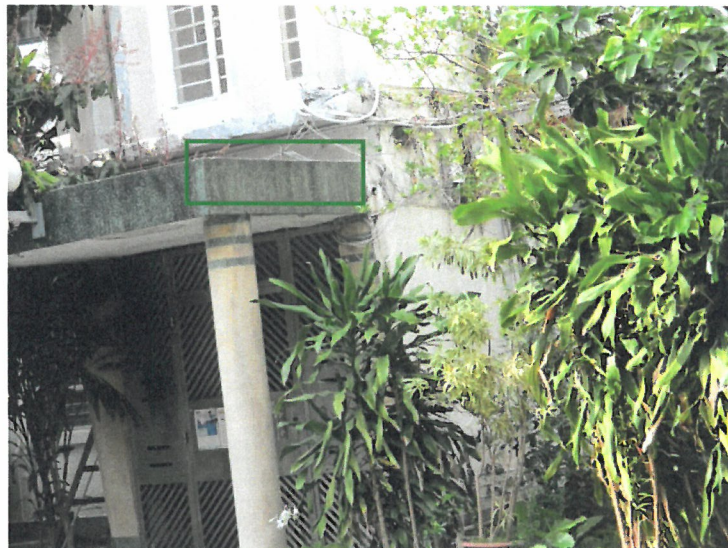
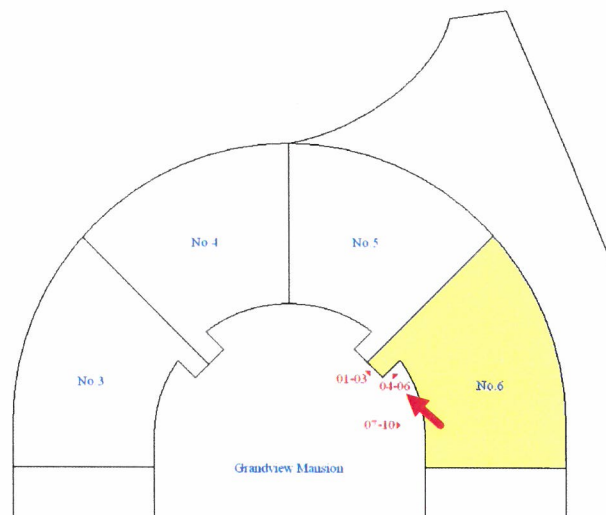
Image 圖譜: 06
Location 位置: Stage 6 Grandview Mansion 偉景大廈6期
Floor 樓層: G/F

Areas with unusual temperature inside boxes in the infrared spectrum are locations of possible defects
紅外線圖譜中，方格內溫度相對異常的部份是可能缺損的位置。

Classification 分類	Quantity 數量	Estimate Area 估計面積 (m ²)
I (General 一般)	-	-
II (Serious 嚴重)	-	-
III (Other Possible 其他可能)	1	1

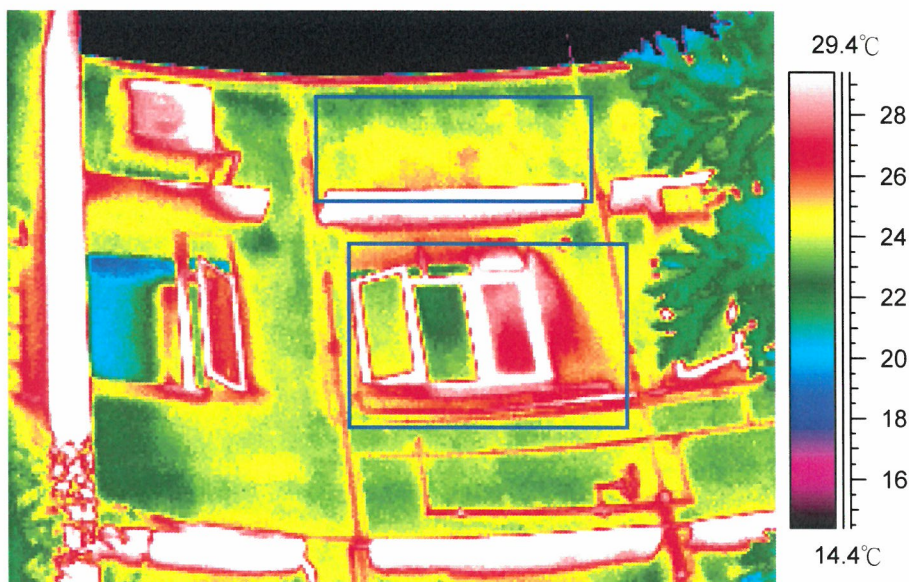
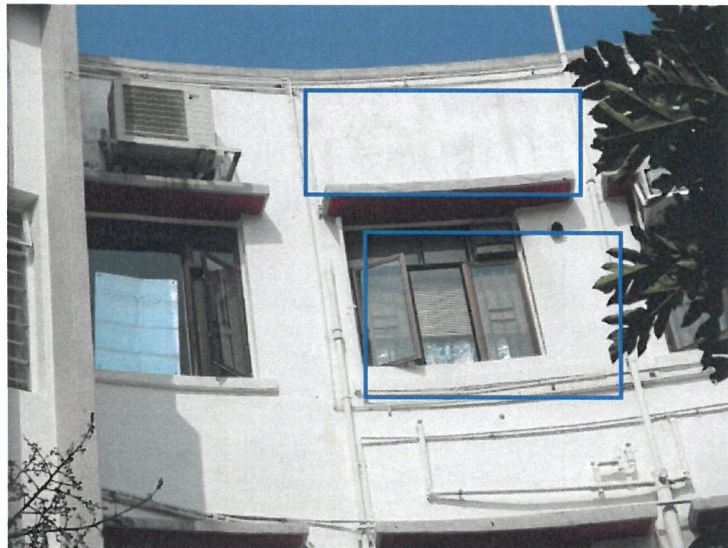
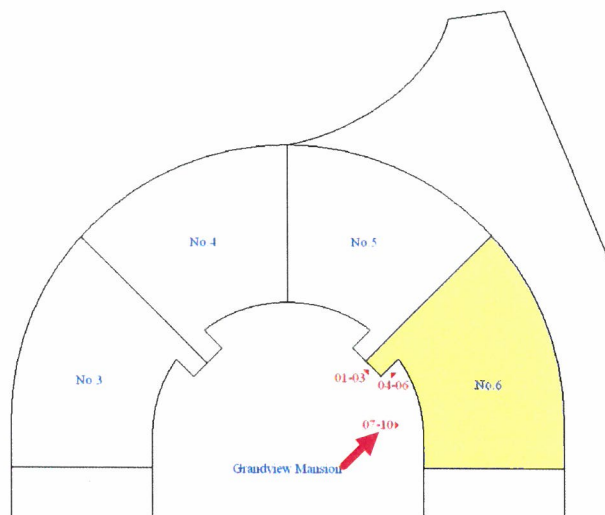
Image 圖譜: 07
 Location 位置: Stage 6 Grandview Mansion 偉景大廈6期
 Floor 樓層: 3-R/F

Areas with unusual temperature inside boxes in the infrared spectrum are locations of possible defects

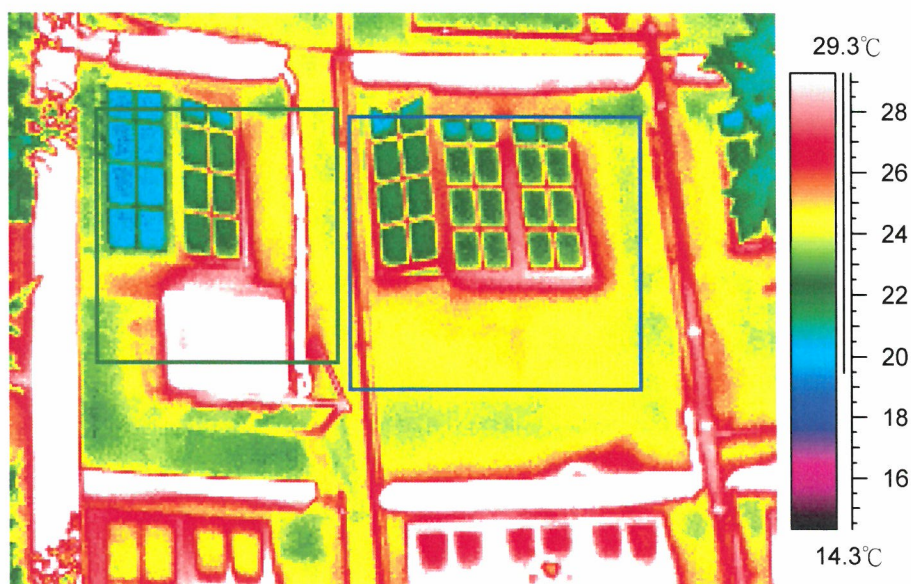
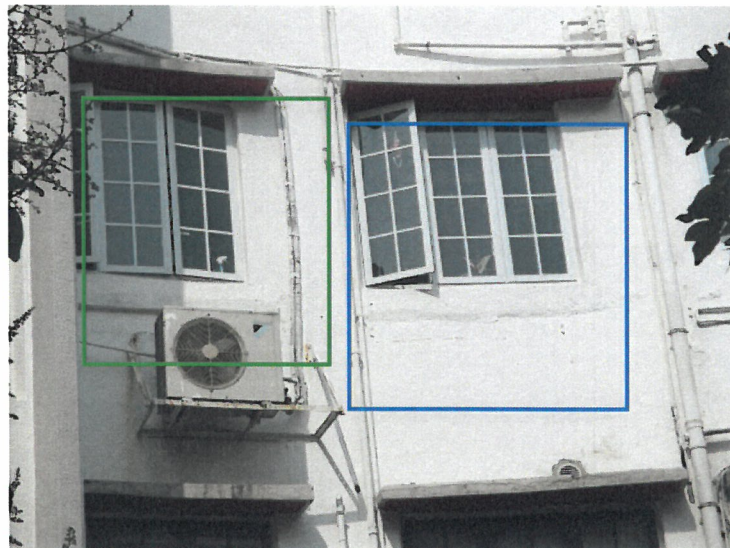
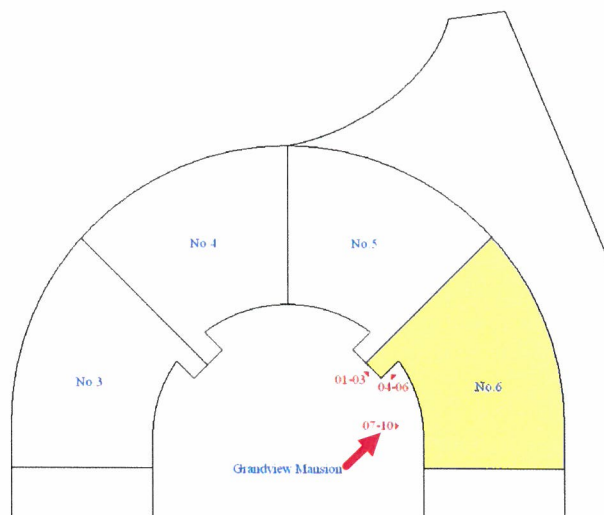
Image 圖譜: 08
 Location 位置: Stage 6 Grandview Mansion 偉景大廈6期
 Floor 樓層: 2/F

Areas with unusual temperature inside boxes in the infrared spectrum are locations of possible defects

Classification 分類	Quantity 數量	Estimate Area 估計面積 (m ²)
I (General 一般)	1	2
II (Serious 嚴重)	-	-
III (Other Possible 其他可能)	1	2

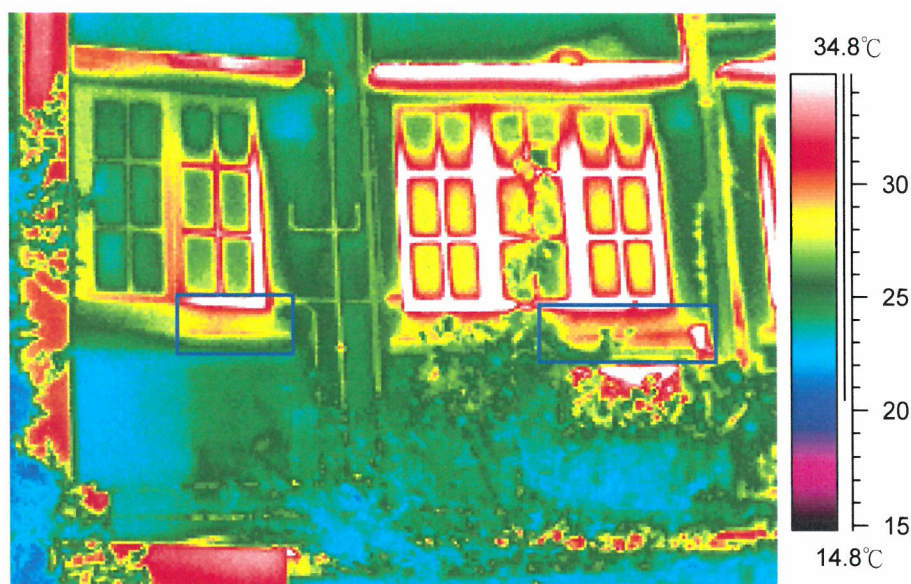
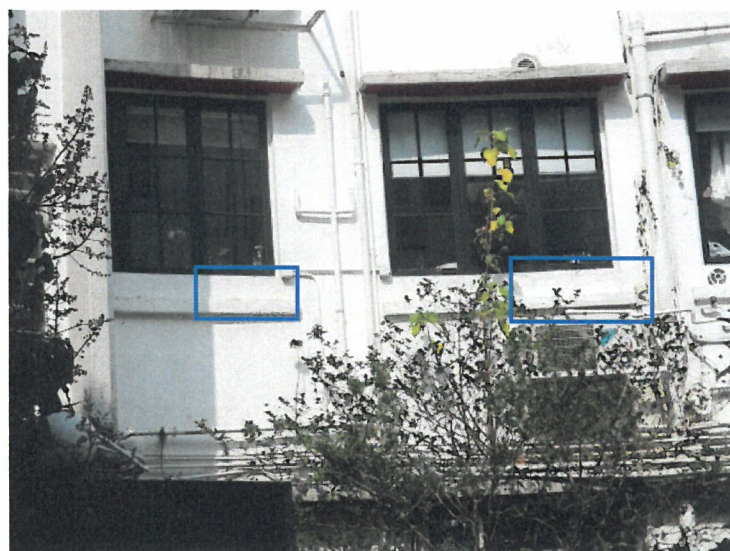
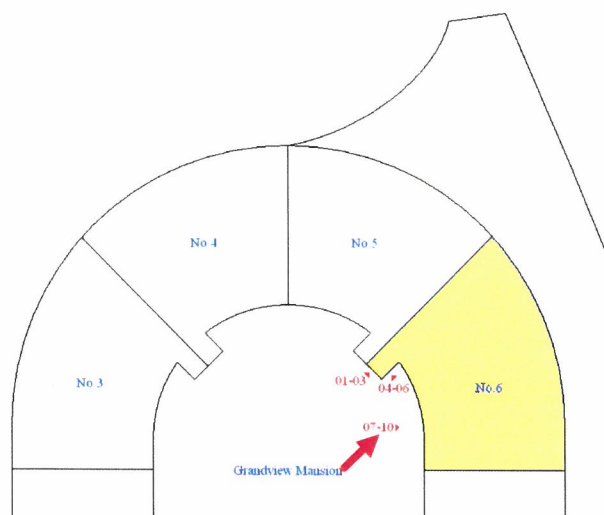
Image 圖譜: 09
 Location 位置: Stage 6 Grandview Mansion 偉景大廈6期
 Floor 樓層: 1/F

Areas with unusual temperature inside boxes in the infrared spectrum are locations of possible defects

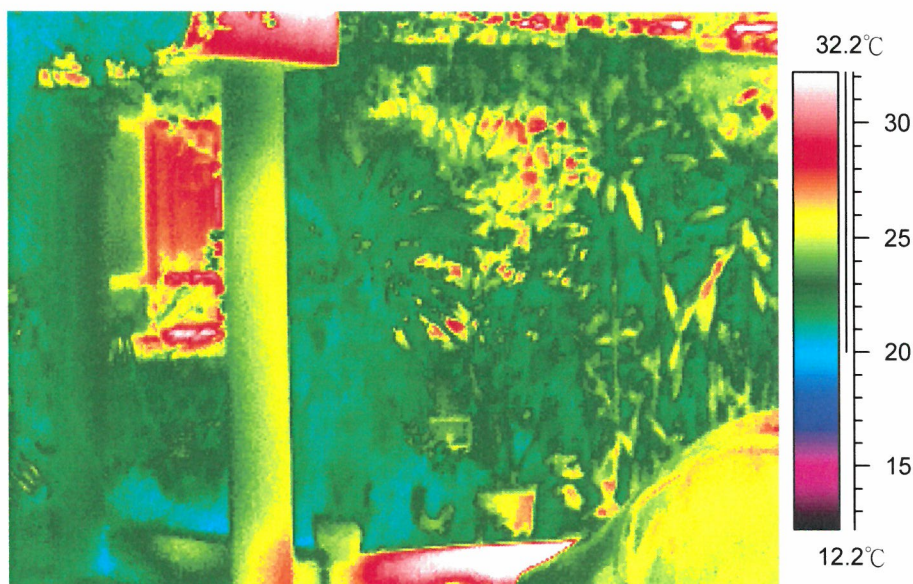
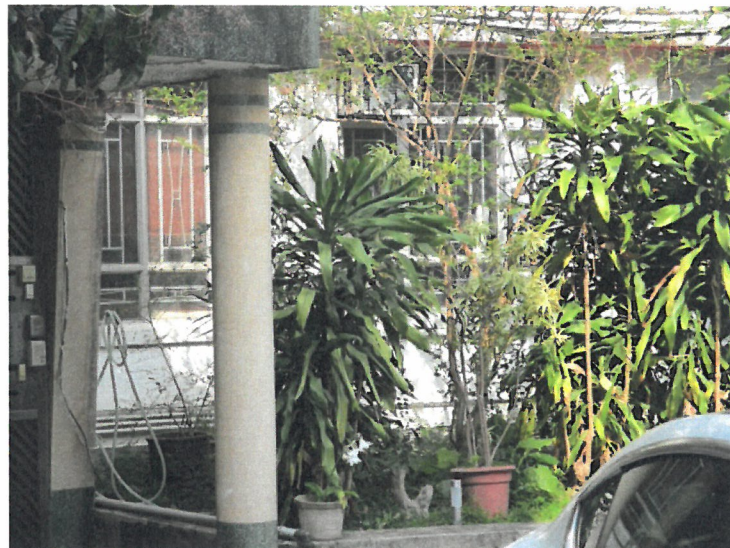
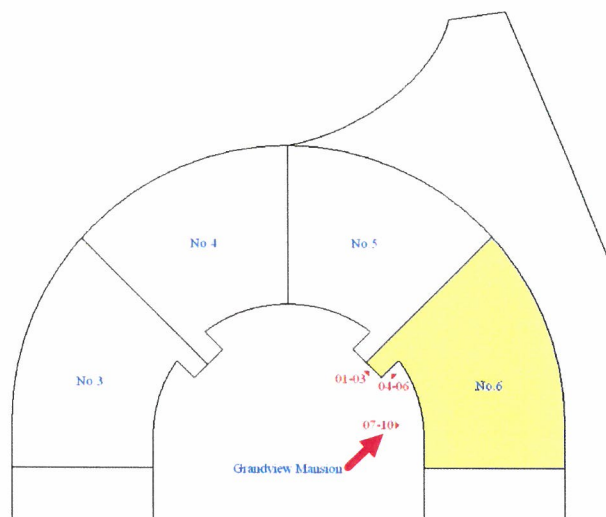
Image 圖譜: 10
 Location 位置: Stage 6 Grandview Mansion 偉景大廈6期
 Floor 樓層: G/F

Areas with unusual temperature inside boxes in the infrared spectrum are locations of possible defects

Classification 分類	Quantity 數量	Estimate Area 估計面積 (m ²)
I (General 一般)	-	-
II (Serious 嚴重)	-	-
III (Other Possible 其他可能)	-	-
